## Issues found with 1st assembly JD

## Issues found with functional testing

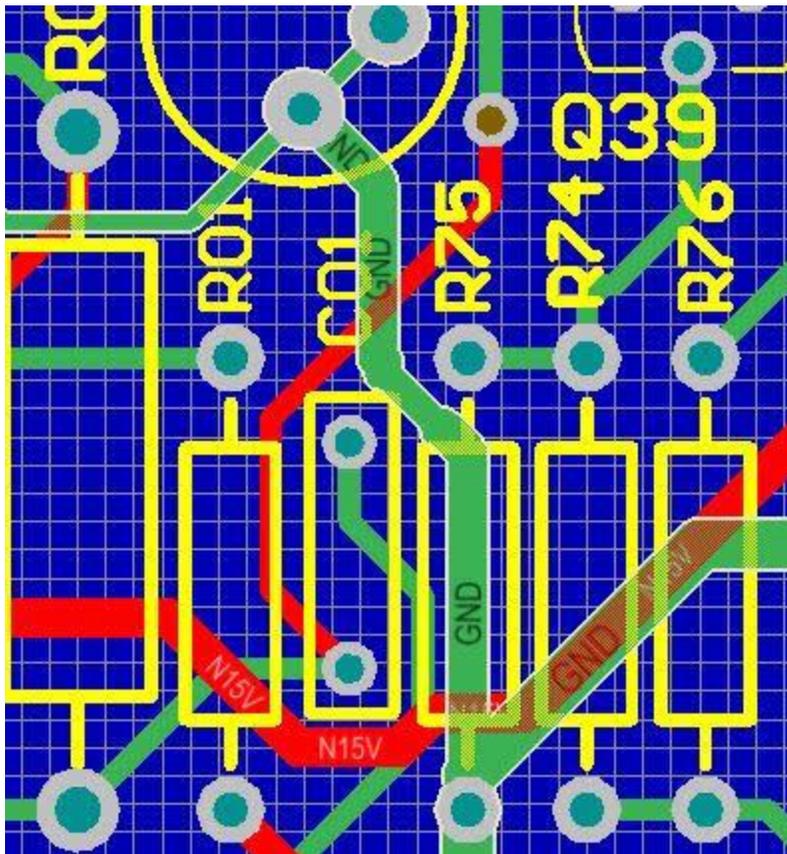
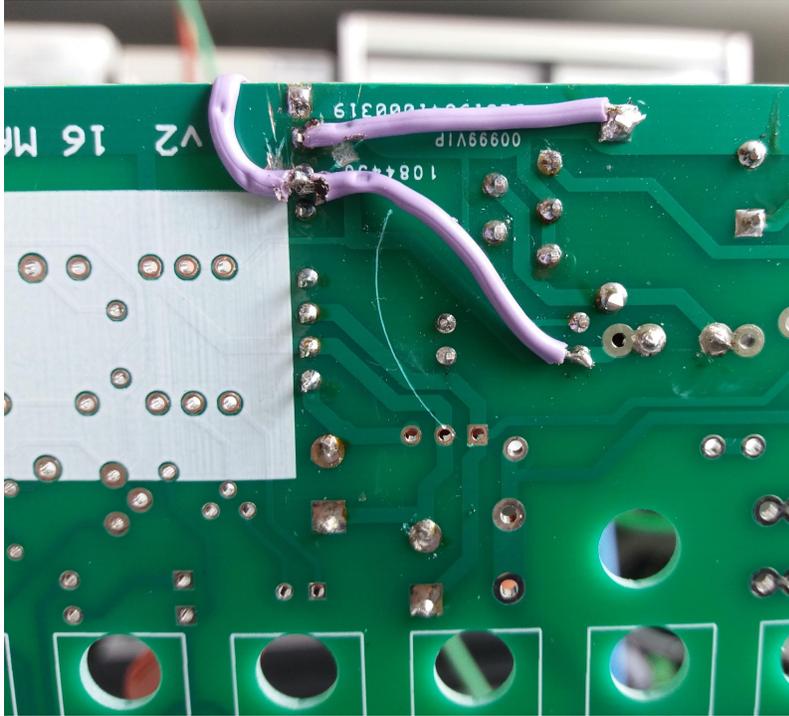
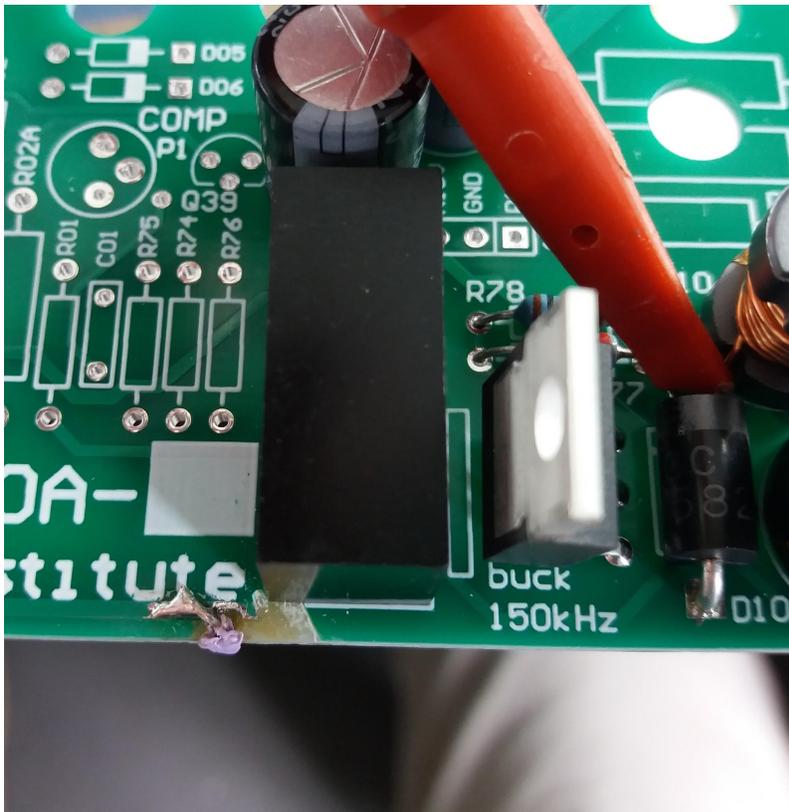
Here's the layout for C01. You can see there's a via between the trimpot and Q39. You can cut the continuing trace under, and add a wire from the via, over to Q25. But, it'd be convenient to do this before mounting the surrounding parts. If you want to experiment, you can always move the far end of the wire later (that end of the cap is at low-Z, without sensitive wiring issues). And C01 is well exposed, so you can play with its value. Tacking an extra cap to the pins underneath may be a good way to experiment, or you may want to stand up the part a bit so you can snip wires and solder parts on top. Yessir, I'm sure y'all have experience doing things like that.

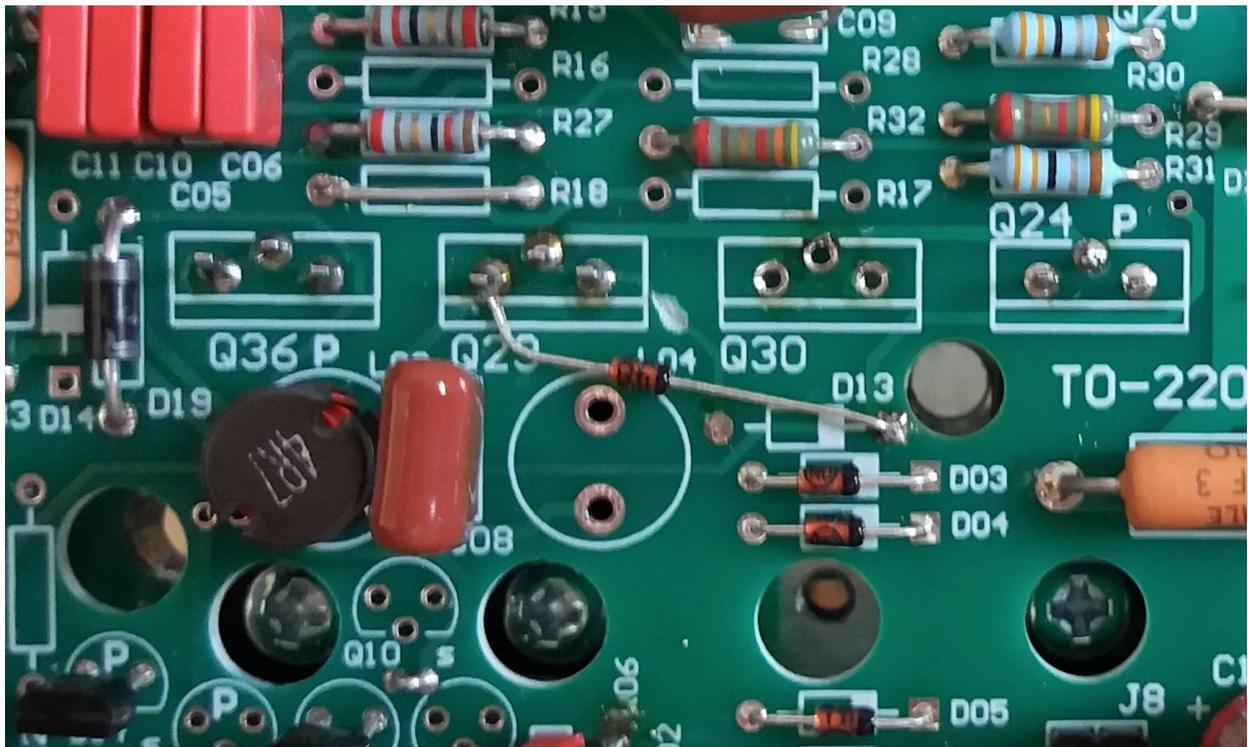
1. Space between PM3, PM3 and electrolytics C26, C27 is tight. Use smallest diameter electrolytic available.
2. There is a difference in connection between clamp diodes D12 and D13. D12 runs from Vc to **EQ15**, while D13 runs from **BQ29** to Ve. It appears that the D12 connection is correct. The D13 connection to **BQ29** should be changed to **EQ29**.
3. Did the modification: cut the trace on the top between BQ29 and Anode-D13. Then mount new D13 between original pad for Cathode-D13 and EQ29. See picture below. Functional test OK.

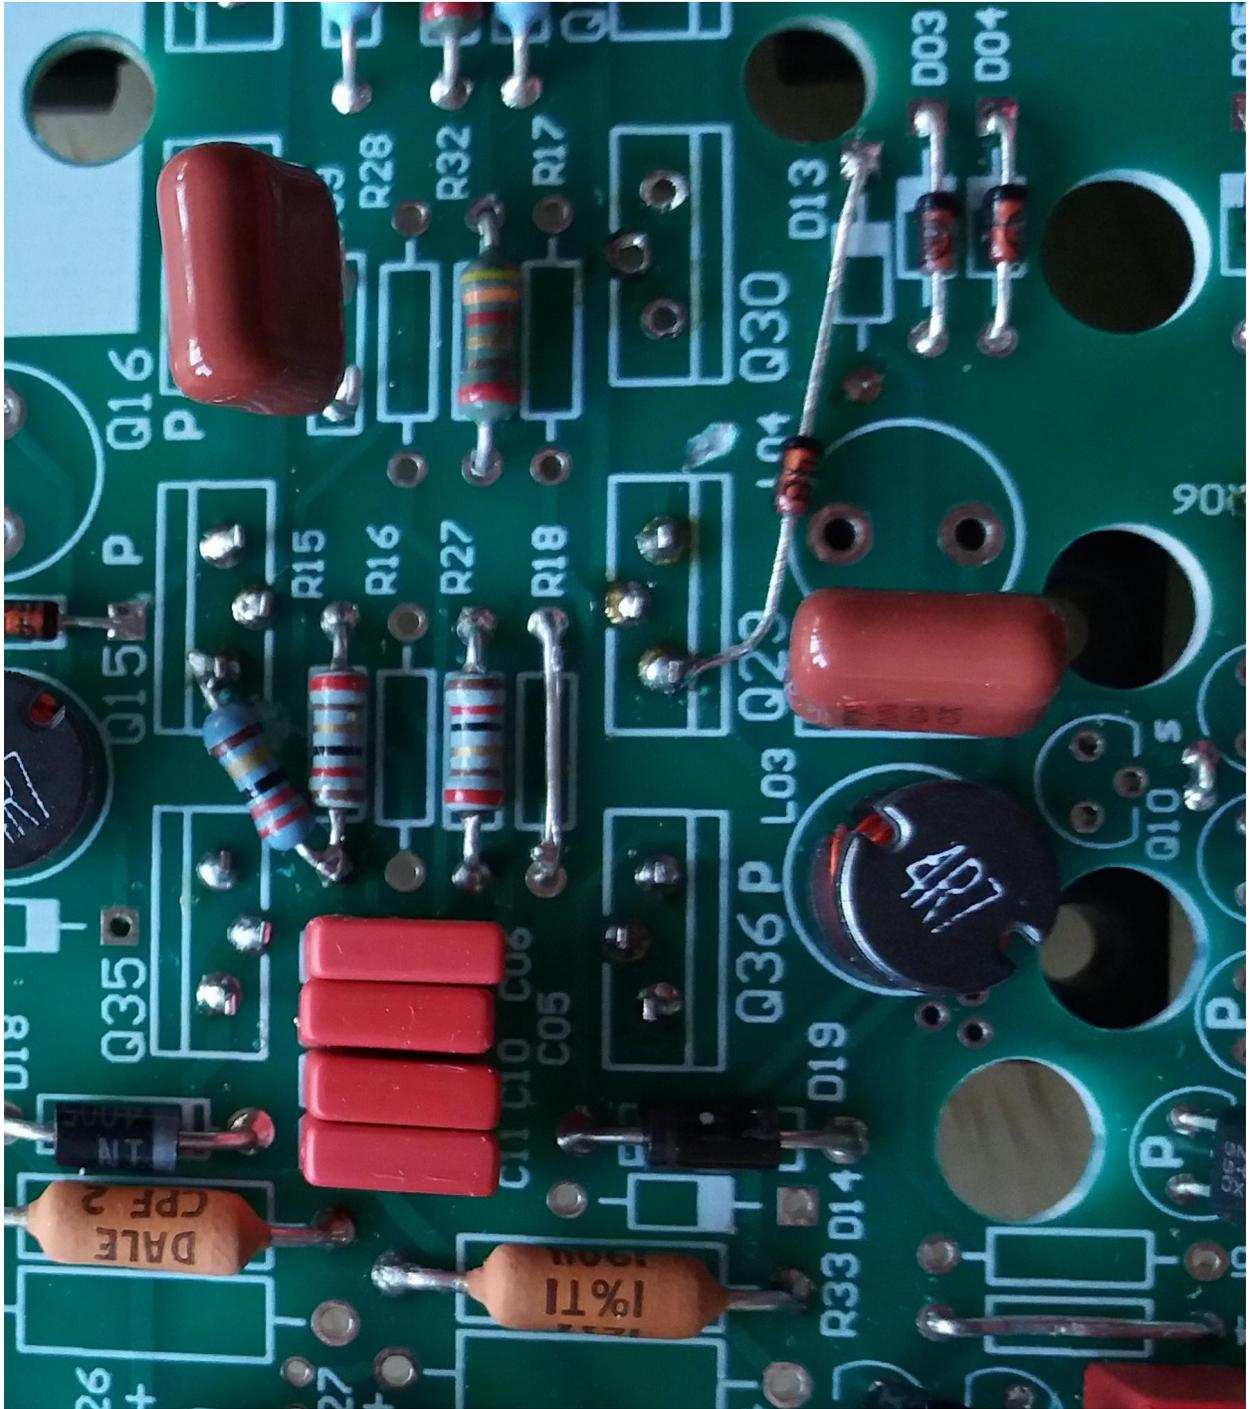
Q15 base stopper

5. The 2nd oscillation which looked more like 'squegging' was not influenced by P1. Reviewing the construction and test report from the German Tigris group revealed that they had similar issues. This was solved by inserting a  $22\Omega$  base stopper resistor directly at the base of Q15 and Q29. This completely cured all oscillations. See pictures below. The reasoning was that this stopped HF feedback through the supply lines through C05 and C10.
