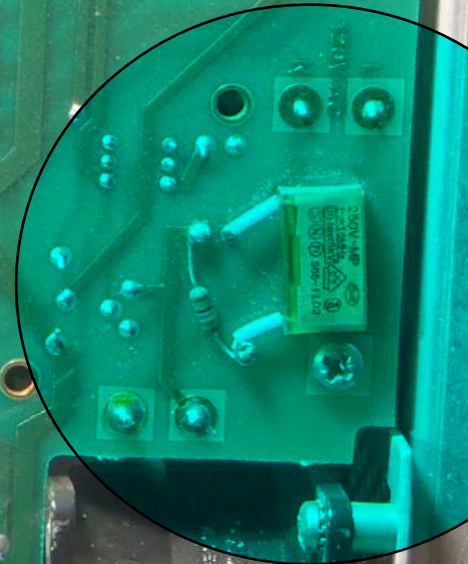
One of 3 RIFA caps visible in the unit shown here. They were all cracked in classic RIFA fashion. I don't know what that plastic formulation was that they used on these parts, but boy, RIFA really got a bad deal on the stuff. It's curious that there is no apparent reason for the failure either. No swelling of the cap wad, no evidence of high heat. They's just cracked, like a junk cars windshield.
