Updating the firmware of my Prologix Adapter Rev. 6.4.1

March 18th, 2020

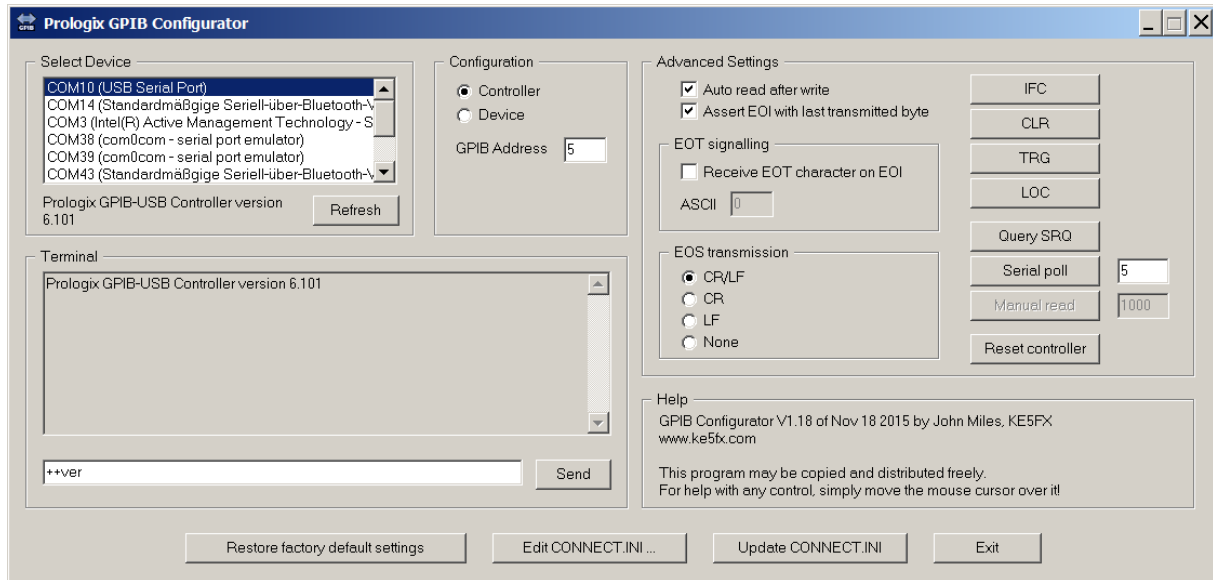
Current firmware version same as of time of purchase is 6.101:

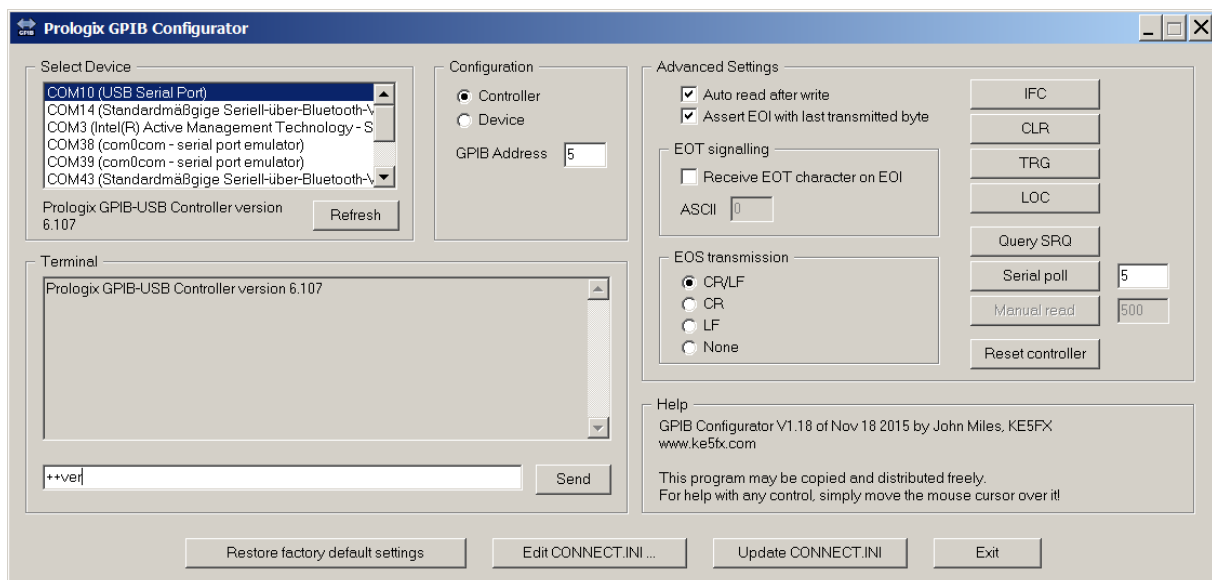
What does the GPIB Configurator say?

6.107, so success!

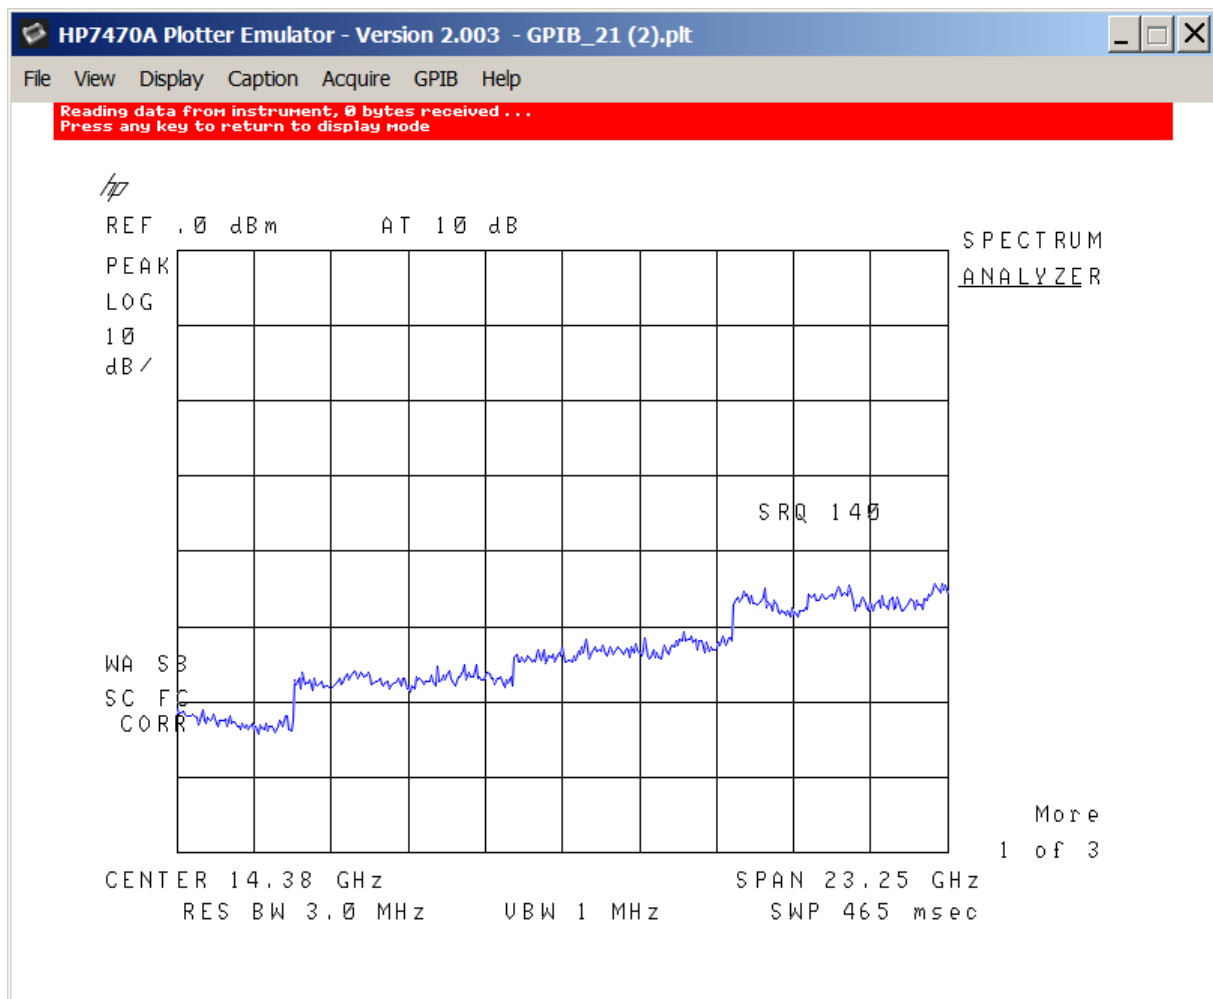
Pressing the "w" key puts 7470.exe into listening mode:

But when pressing the SA copy-button, nothing happens, no plot data sent.

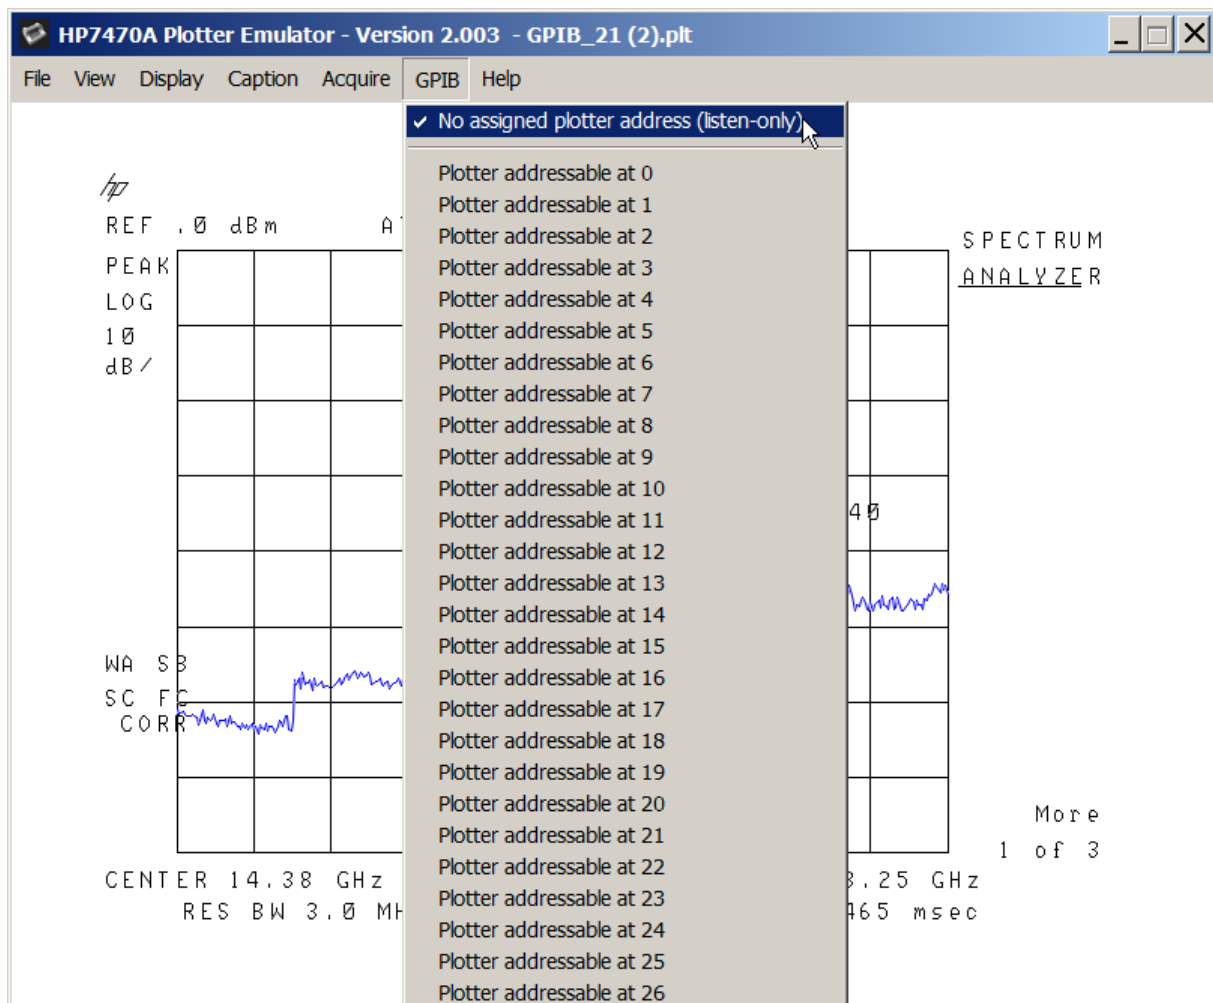
How about unaddressed mode?

Same thing, after pressing "w" key in plotter and pressing SA copy key no data coming in.
