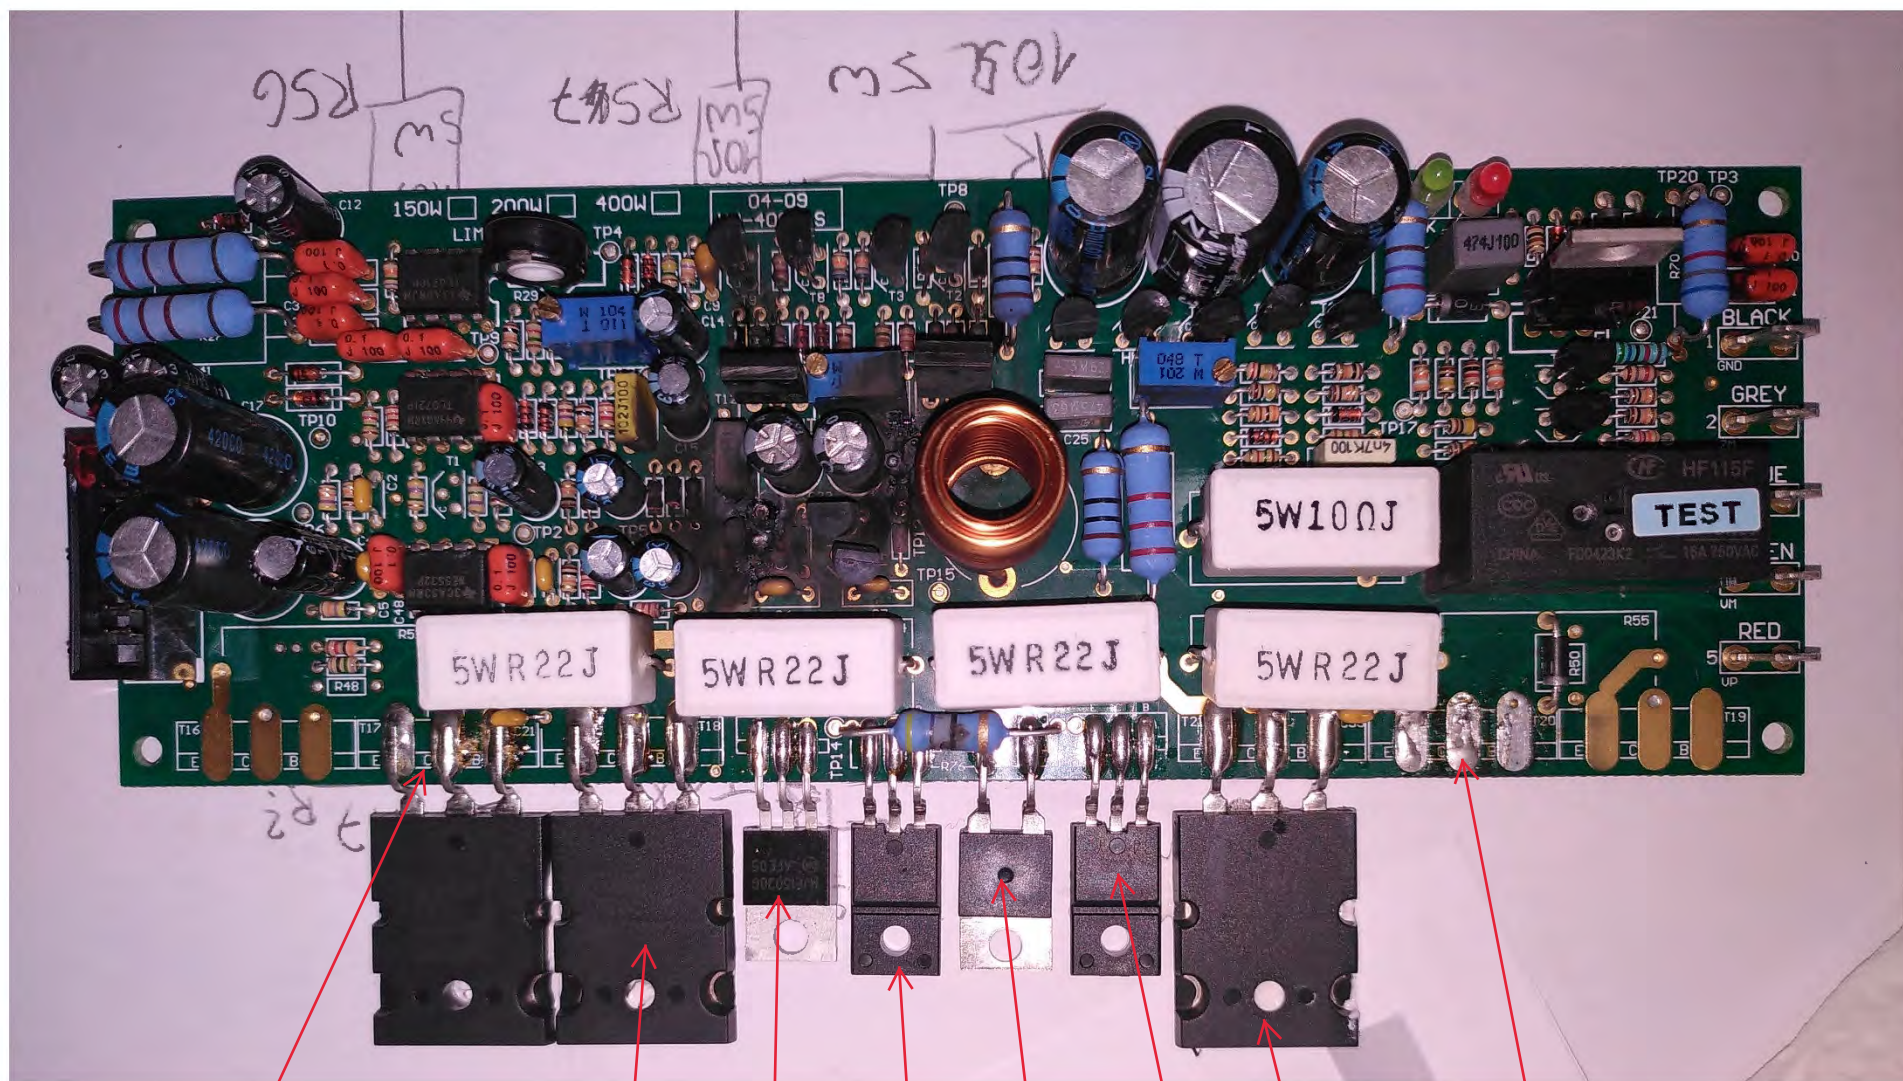
T17 solder joints
look strange, but
transistor seems
ok

T18 complete short

T13 complete short

T14 complete short

T15 complete short

T21 complete short

Thermal switch -->
closed contact

T20 already
removed by me,
seems ok

T3 solder joints seem to have gotten hot.

T9 solder joints seem to have gotten hot.

bodge SMD transistor T1 from someones previous repair ?
