Review of T100 Oscilloscope differential amplifier

Sort of continuation of <https://www.eevblog.com/forum/testgear/cheap-chinese-oscilloscope-preamp-tear-downreview-is-it-any-good/> around two years later (2024.07), aimed to make more measurements and highlight some changes.

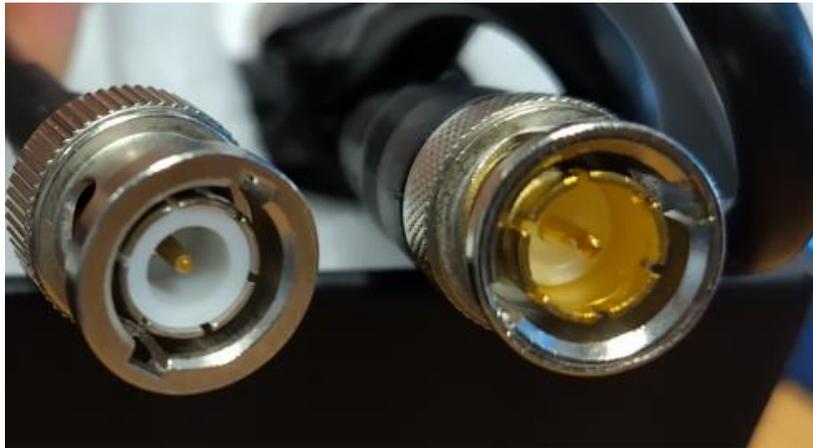
Figure 3 Left – 50 Ω BNC, right – 75 Ω cable supplied

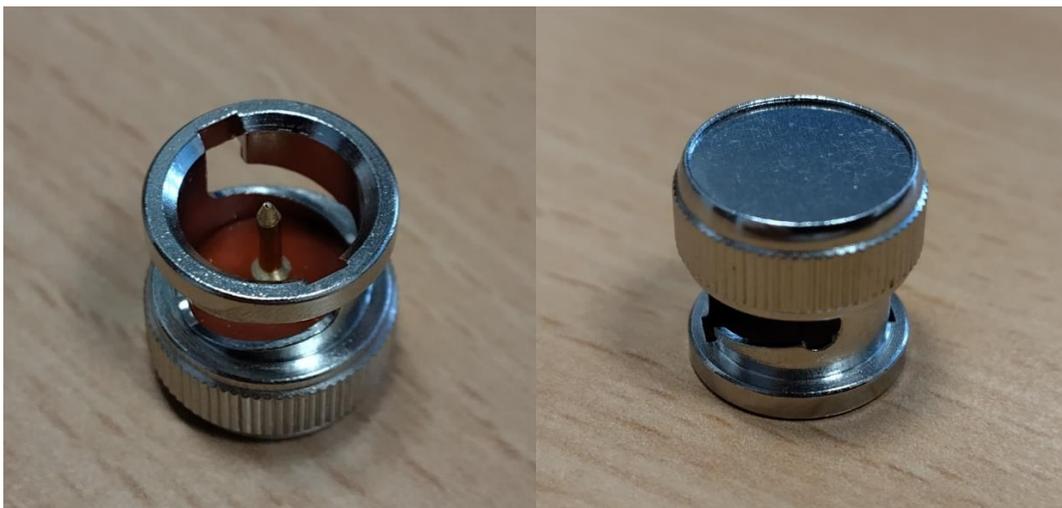
Figure 4 Shorting plug

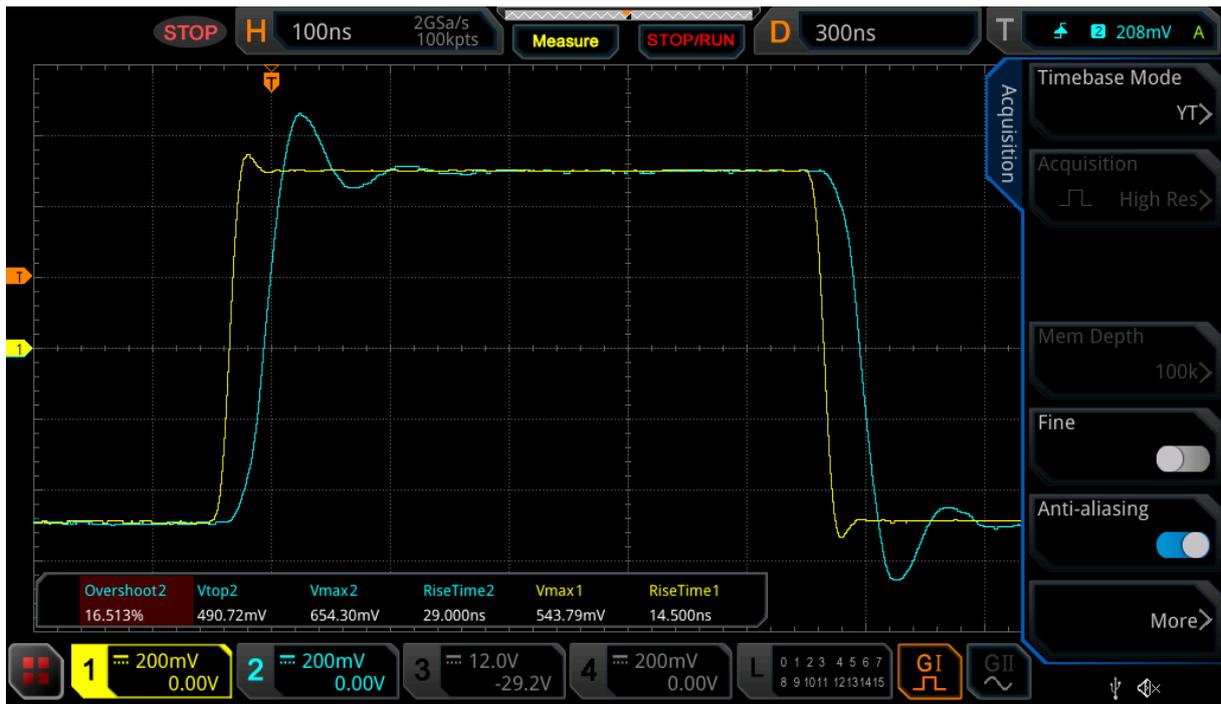
Figure 6 Overshoot at G=1

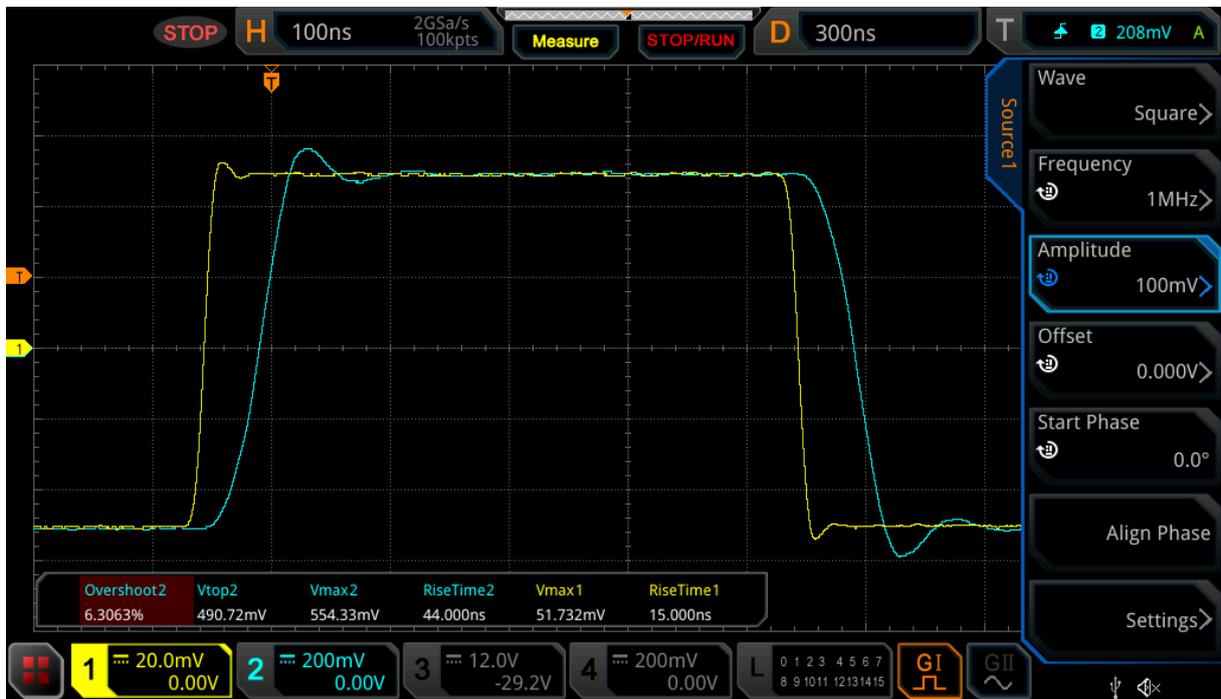
Figure 7 Overshoot at G=10

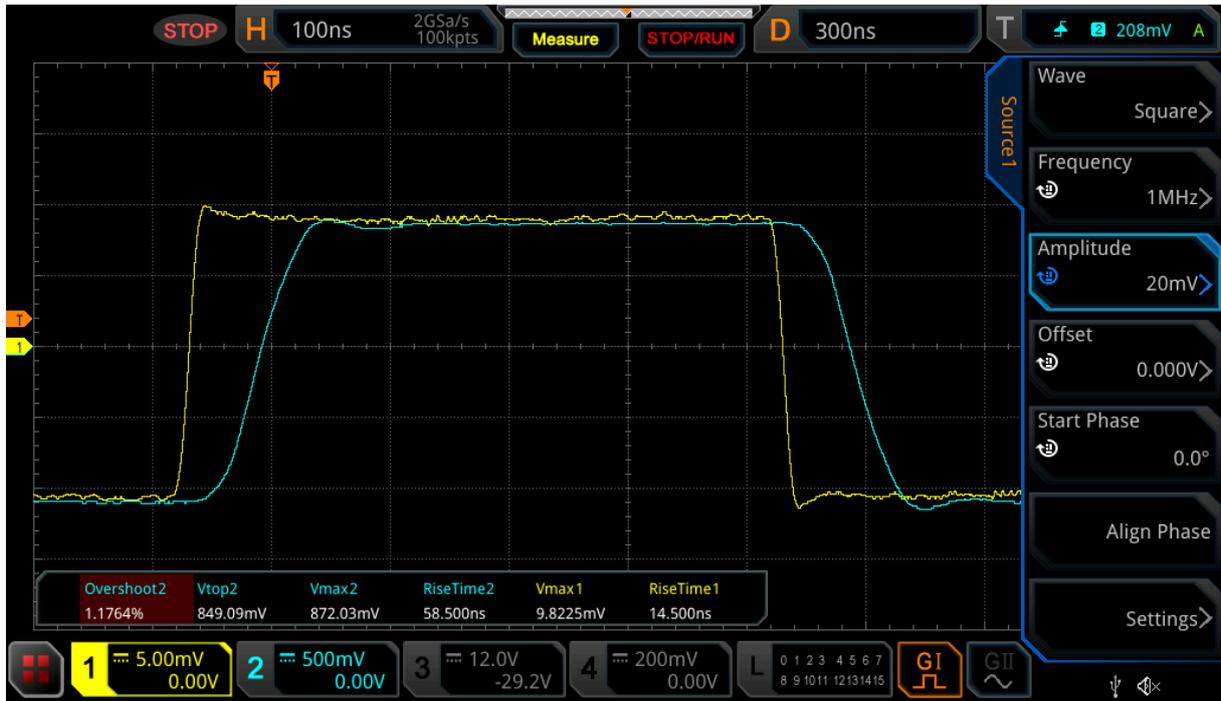
Figure 8 Overshoot at G=100
