LTC2057

rev B, Jan 8, 2019 Added results of testing to determine if convection in the air were causing the flicker noise. They are not.

Chuckb, Jan 5 2019

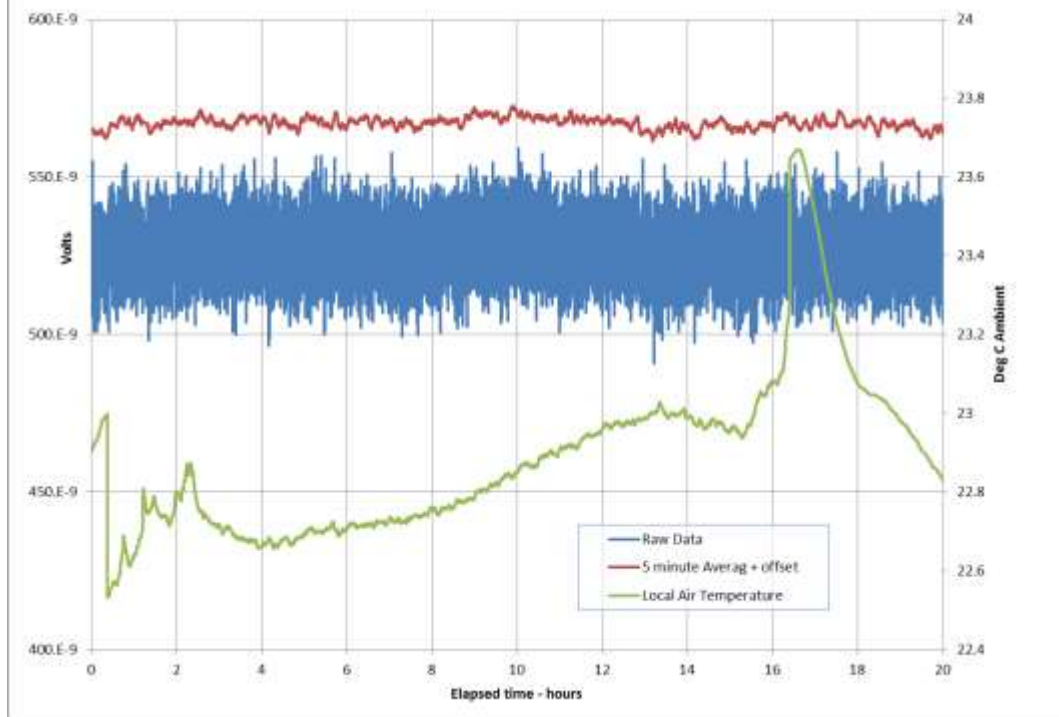
To check for possible electrical noise generated by thermoelectric junctions and convection air currents, the gain setting resistors and the opamp were covered in 3 layers of GAP PAD and tested for 20 hours. I could not detect any difference other than a fixed 10nV offset probably caused by component temperature change.

The Peak to Peak noise was the same. The White noise and the Flicker noise floor in the MAD plot were the same.

LTC2057, +5Vdc, Gap Pad covering gain resistors and OpAmp
