A dedicated two layer PCB was built and assembled to test the voltage flicker noise of different chopper amplifier ICs. The chopper current noise spectrum will not be evaluated at this time. The PCB has three locations for amplifiers to be tested. Each of the three locations can support a DIP, SOIC8 or MSOP8 package. One of the three locations is wired for a dual opamp. Only one of the dual op amp channels is evaluated (pins 1, 2 and 3). The other opamp is configured for a gain of 1 and the input is grounded. Each PS input to each opamp has a 0.1uF ceramic SMD cap and a 100uF Aluminum Electrolytic cap to ground for bypass.

Minimizing EMI influence – reference schematic

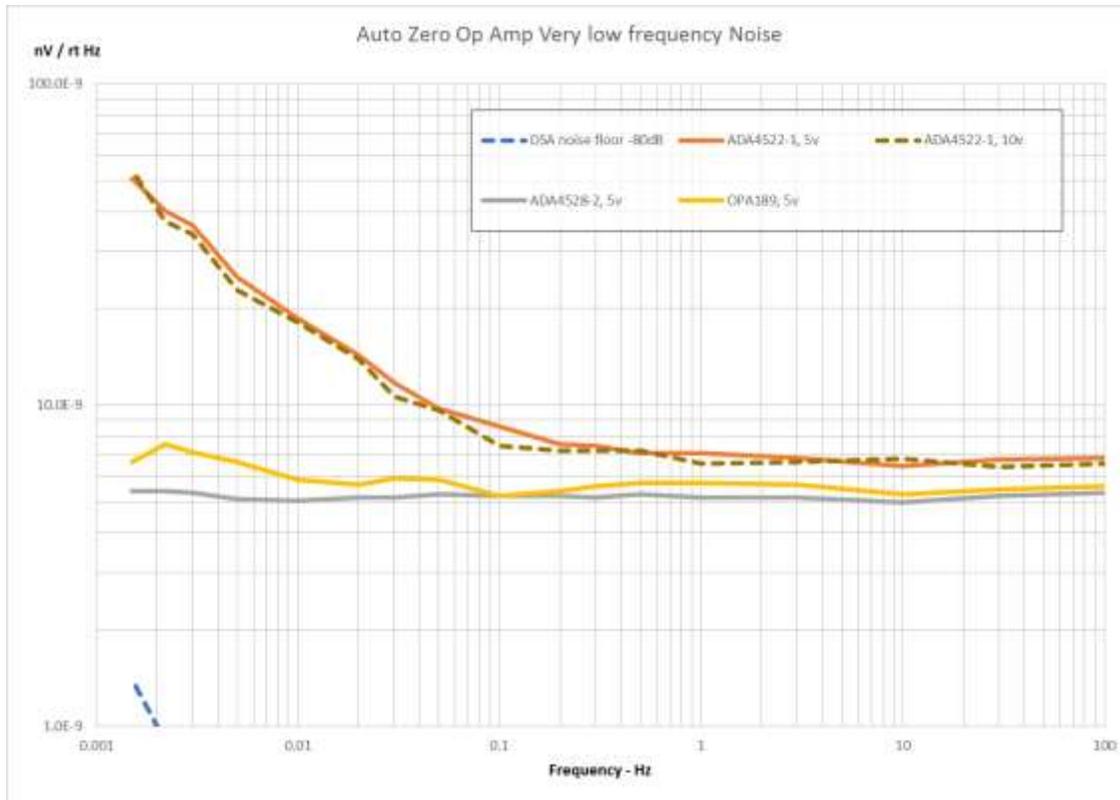
At the conclusion of the 1<sup>st</sup> round of testing the OPA189, ADA4522 and ADA4528 opamps were replaced and the testing was repeated. The noise density spectrums were within 1 dB of each other.
